CASE STUDIES OF SLOPE STABILITY RADAR USED IN OPEN CUT MINES

Dr Neal Harries, Dr David Noon, Mr Keith Rowley
The South African Institute of Mining and Metallurgy

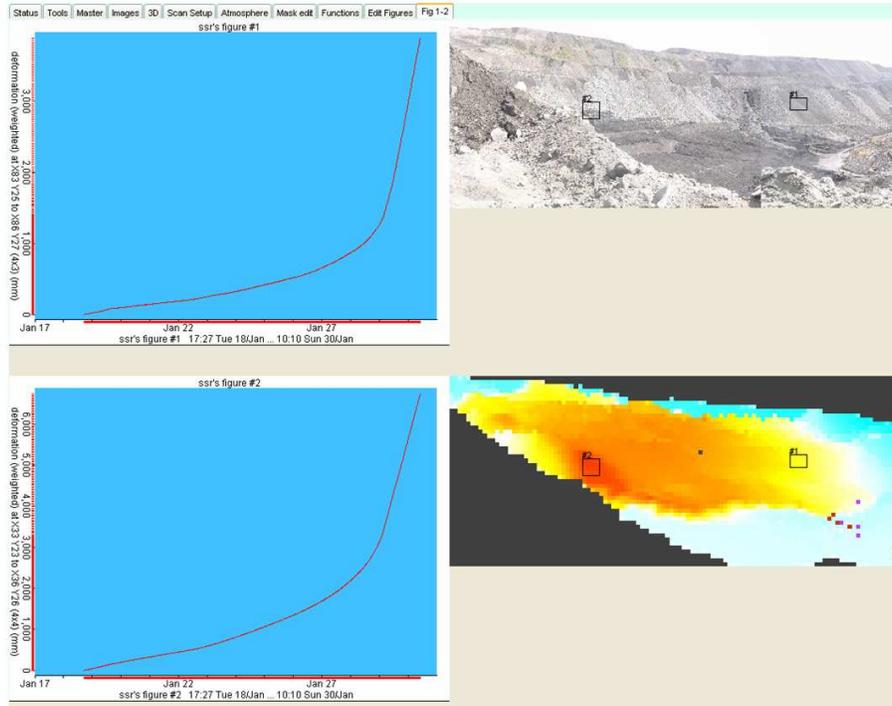
Figure 1: SSR Visual of the Mt Owen Wall Failure (with Selected Displacement Plots)

1. The slump was a multi-bench, day lighted circular failure.
2. The material that slumped was spoil that formed part of the mine dump and access roads to the dump area.
3. The low wall slumped as a single entity and caused 10-15 metres of floor heave.

4. The official estimated failure size was 15,000,000 to 30,000,000 m³.
5. The slump occurred at approx 7.40 am 29/01/2005.
6. Deformation up to 1000 mm in the area of the slip was recorded at the time of failure. The deformation data in Figure 1 is colour coded and clearly shows movement over the whole slump area. Note the absence of detectable movement around the well defined slump area. The two graphs show points within the moving mass which show characteristic acceleration (progressive failure response) prior to failure.

Mount Owen was monitoring an unstable low wall using traditional methods for over twelve months. When the movement rates became excessive, the mine utilised the SSR which commenced on 13th January 2005. The monitored wall is concave, with the SSR positioned to the extreme left hand side (see Figure 1).

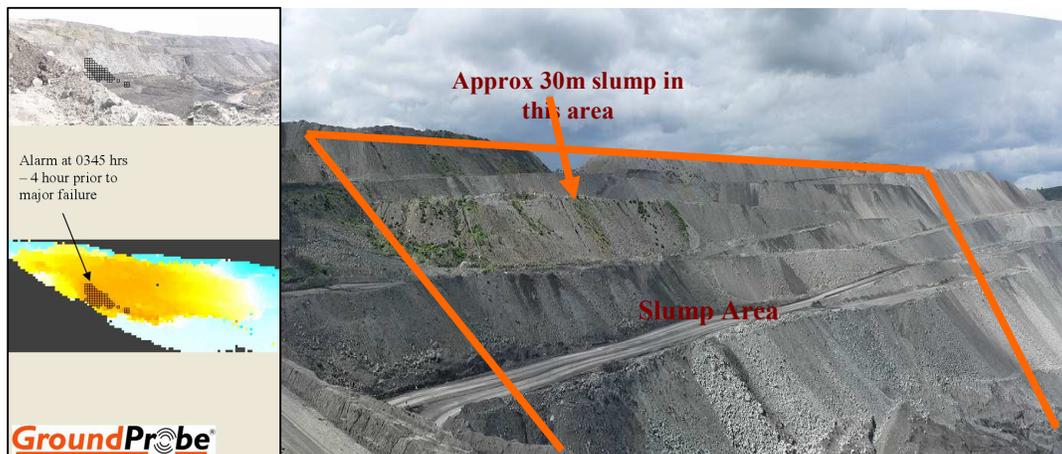
Figure 2: Visual of Alarm Trigger and Failure Surface

1. The red alert was first sounded at 03:43 on 29/01/05 (see Figure 2).
2. The alarm procedures were followed by the control room staff.
3. The slump occurred at approx 07:40 on 29/01/05.
4. The movement detected was consistent with that set in the alarm parameters.
5. Using the alarm settings discussed, approximately 4 hours of warning was received prior to the impending slump.

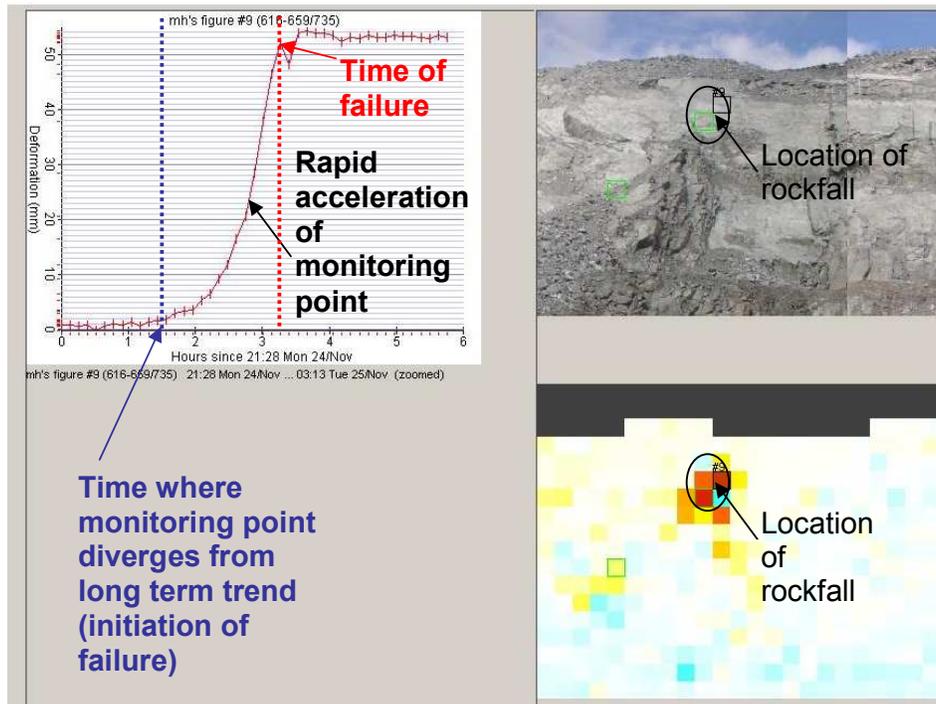
The SSR response from the first rock fall captured by a SSR at an African Mining Operation is shown below in Figure 3.

It occurred two weeks into the initial field trial and was a small 300 t failure. The failure can be seen to develop on the SSR deformation plot, where 54 mm of movement was seen over 240 minutes prior to actual rock fall event (when the failed rock detaches itself from the face). Even with a small failure in a brittle rock mass, the SSR did provide over an hour of warning which would allow the area of concern to be cleared of personnel and equipment.

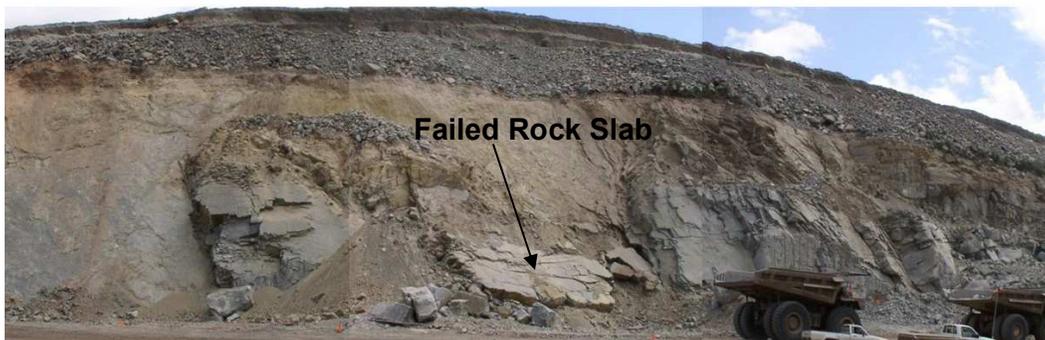
Figure 4: Small Rock Slab Failure

The second example highlights failure associated with active mining (excavation). In this example a small (less than bench height) rock slab failed due to excavation at the toe of the slope. The small size of the rock slab can be seen in Figure 4.
